About Horner Mill

The Conversion

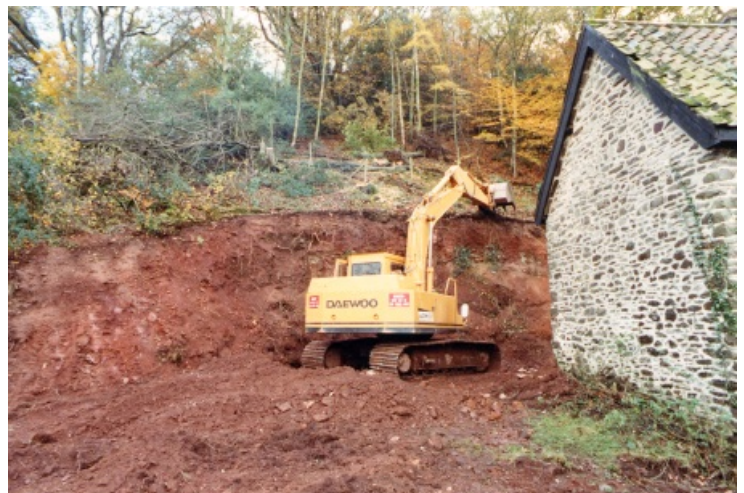
Excavating the drive area

Work started on the mill on the 6th November 1990 and was almost complete when we moved here in August 1992. The first eight days of work were spent removing 4-5 ft (1.5 m) of the relatively soft rock underlying what is now the drive area. This brought the ground level down slightly below that of the main floor in the mill, and significantly improved vehicle access. The concrete for the corn silos was broken up, mostly by hand, and removed, along with about a 9 ft depth of rubble infill in what had been a room below the floor.

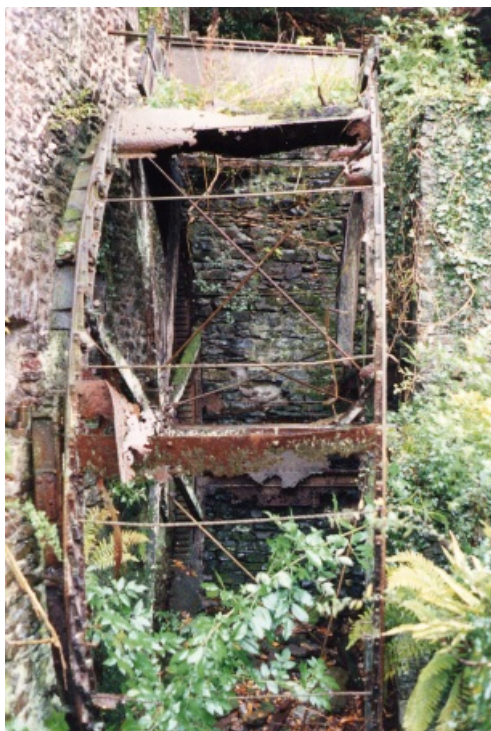
The water wheel before restoration

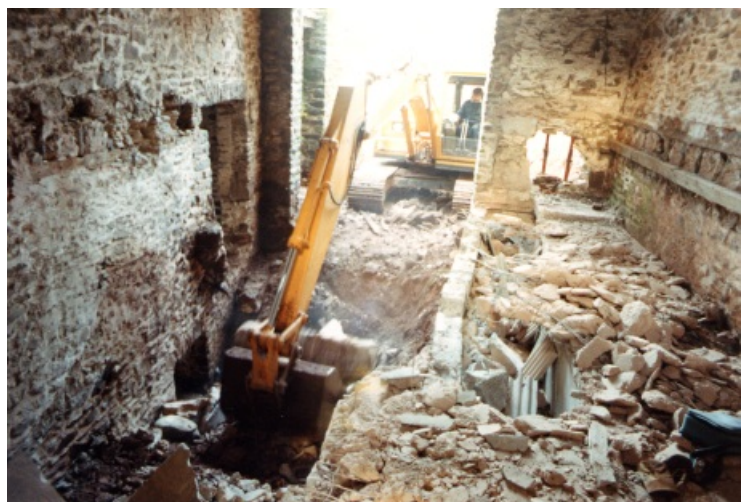
Removing the corn silo base and the rubble infill

Once all the concrete and rubble had been removed from the rear section a 6" reinforced concrete floor was laid to what is now the garage, a room about 6 ft wide being retained underneath it. A staircase, and short access corridor, was provided to this room from the kitchen.

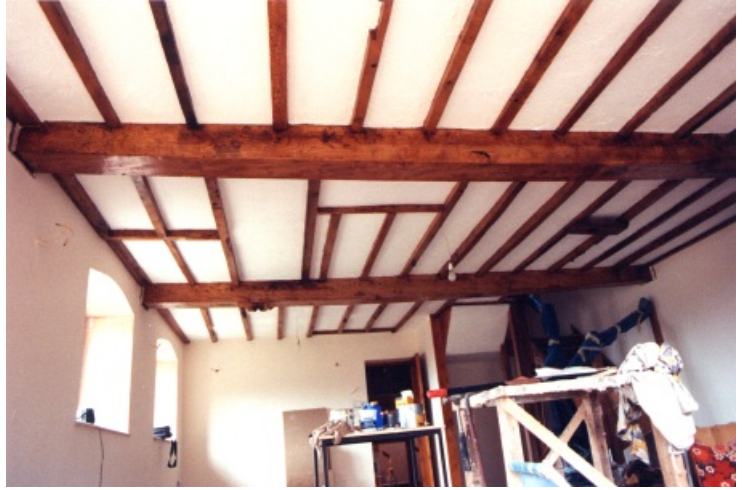
The finished ceiling retaining the old beam positions

New floors were laid in the kitchen and the ground floor of the front part of the mill. Where the floors remained in the main part of the mill they were repaired and kept at their existing levels. For the upper floor, new structural timbers were placed between the old, unsound timbers, so that the original look of the place was retained. Fortunately the original oak framing for the corn stones floor had survived almost intact, new floor joists and floor boards being provided as necessary.

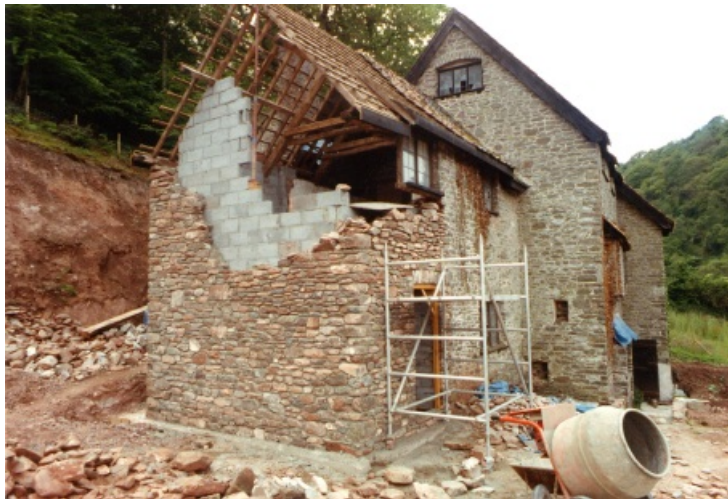
Re-building the kitchen block

The problem of the damage to the corner of the wall of the kitchen block was resolved by stripping the tiles from half the roof and then removing and re-building a large section of the wall. The job was made more difficult as the wall, although 2 ft thick, was only held together by red mud and then pointed on the outside. Removing a small section to carry out a local repair was therefore impossible as the rest of the wall simply fell down! Fortunately the stonework comprising the chimney was held together with lime mortar. The new section of wall was provided with a metre wide concrete foundation, the rest of the kitchen walls and chimney being underpinned.

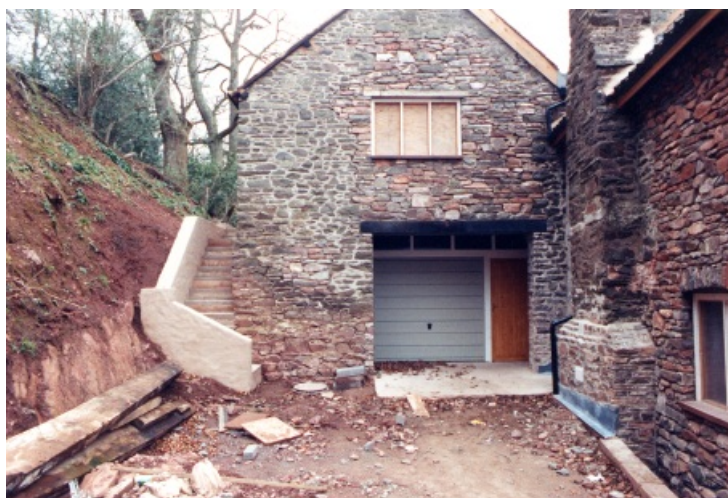
A view of the rear of the mill showing the garage entrance. The mark on the wall between the fire escape stairs and the garage door shows the ground level before the excavation of the drive area.

The areas of unpointed stonework show the extent of the alterations and re-building undertaken.
